NO. 15/2018

START SWITCH UPDATE + REMOVAL OF GREASE

Date 2018 04 20

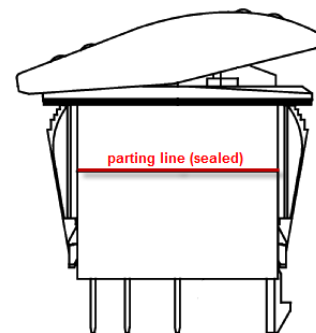
Sealing of the parting line

This improvement has a minor impact but helps to assure the trouble-free operation of the multiple function switch.

IMPORTANT: The sealing prevents water intrusion.

For this reason, the switch must not be opened!

By opening the switch will break the sealing which can cause failure and warranty becomes void.
